# **INDOOR AIR QUALITY ASSESSMENT**

**Lillian M. Jacobs Elementary School  
180 Harbor View Road  
Hull, Massachusetts 02045**

Prepared by:  
Massachusetts Department of Public Health  
Bureau of Environmental Health  
Indoor Air Quality Program  
April 2008

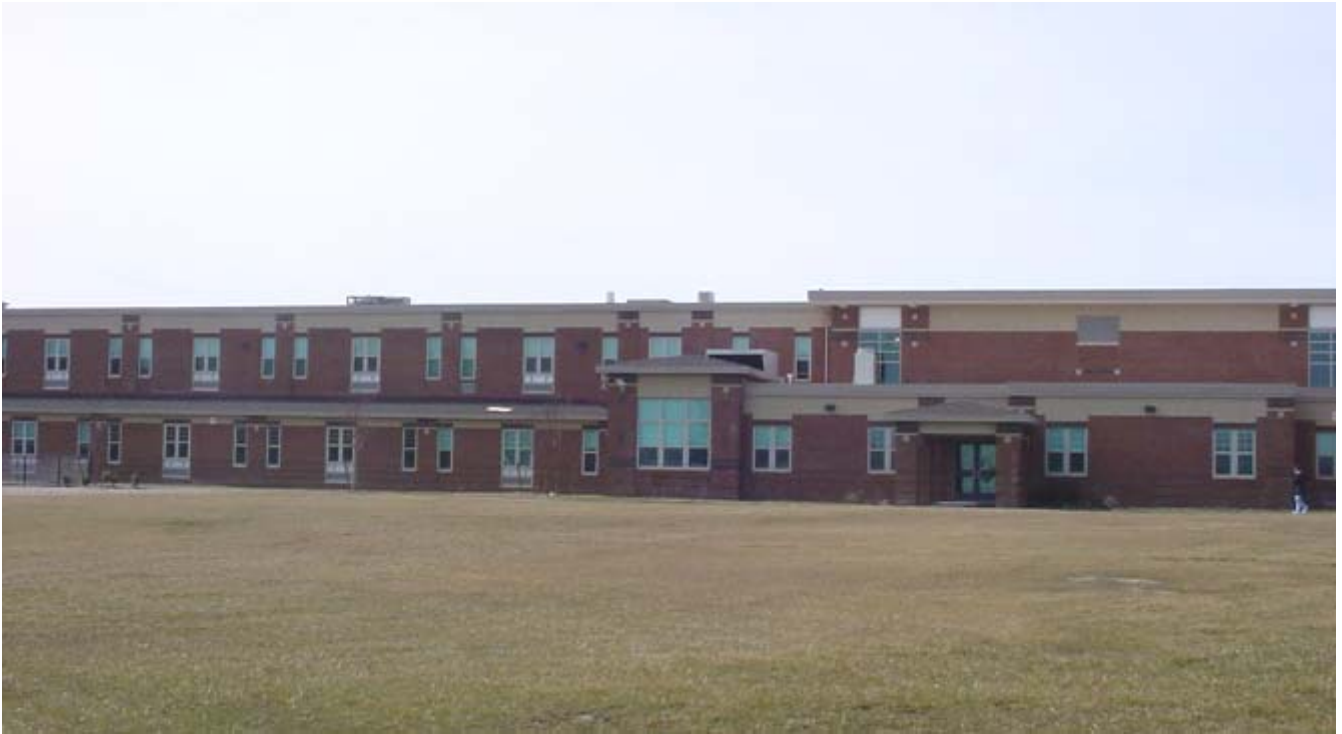
**Picture 1**

**New Addition of Jacobs Elementary School**

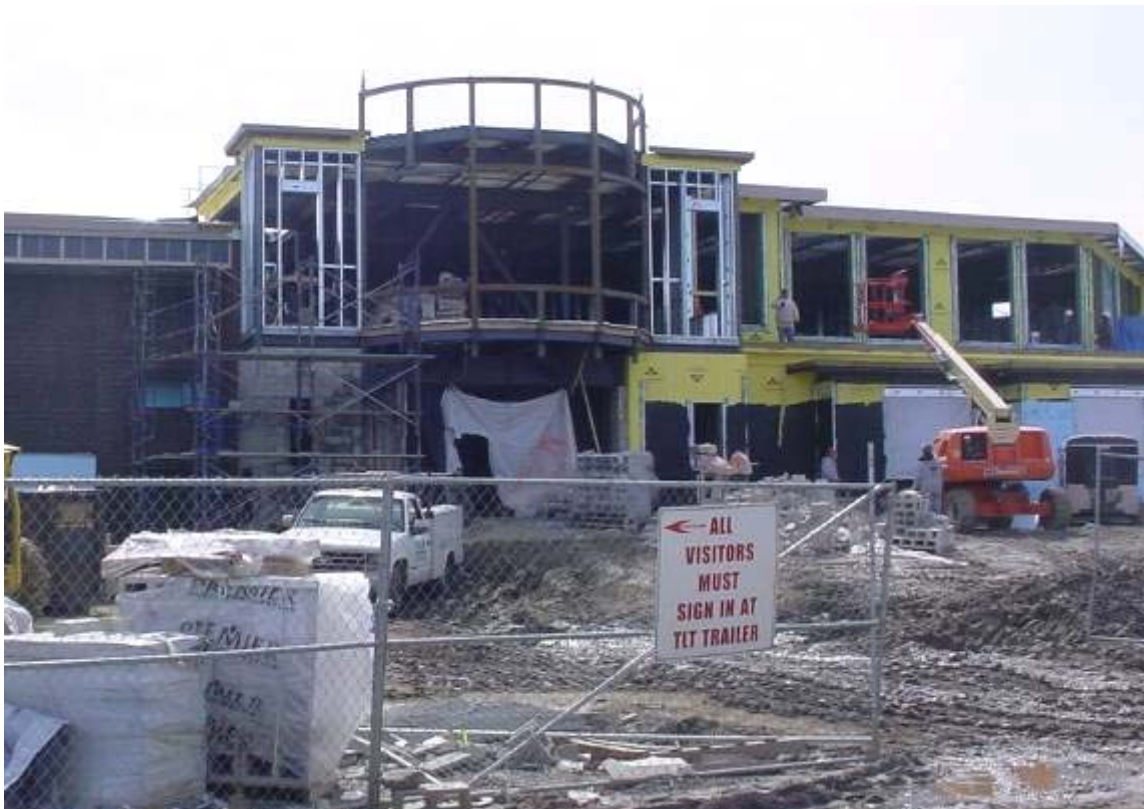
**Picture 2**

**Renovation of Original JES Adjacent to New Addition**

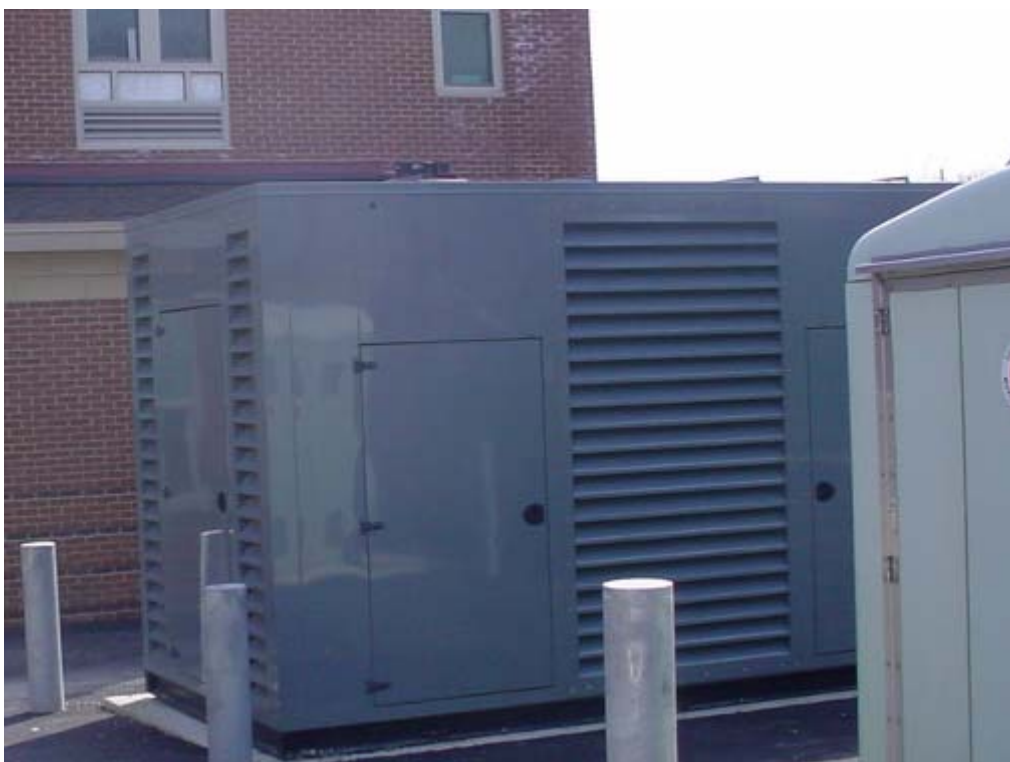
**Picture 3**

As discussed, concerns regarding the entrainment of exhaust emissions from the emergency generator (Picture 3) prompted the request for an IAQ assessment. As reported by

Mr. Twombly, the generator was set on a timer to activate once a week to ensure proper function. The timer was previously set to test the generator on Monday mornings; it has since been re-programmed to test after school hours to prevent/reduce potential exposure to exhaust emissions. In addition, carbon monoxide detectors were installed in classrooms adjacent to the area where the generator is located (Picture 4). Carbon monoxide detectors should be tested and replaced as per the manufactures recommendations to ensure proper working order.

**Emergency Generator at Rear of Building**

1. Continue with current plans to test the emergency generator after school hours.
2. Test and replace carbon monoxide detectors as per the manufacture's recommendations to ensure proper working order.
3. Continue to implement all applicable recommendations listed in the previous MDPH reports, *particularly* those regarding the integrity of *construction barriers* (e.g., daily inspection) and depressurization of construction areas in relation to occupied areas.
4. Refer to guidance concerning 'Methods Used to Reduce/Prevent Exposure to Construction/Renovation Generated Pollutants in Occupied Buildings' available on

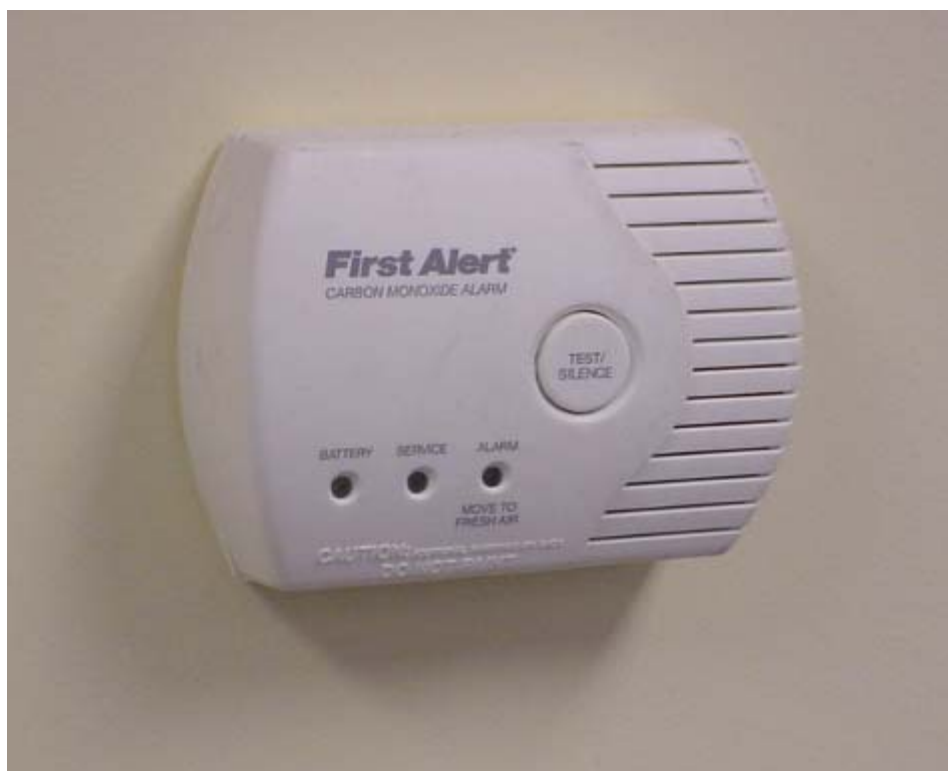
**Picture 4**

**Wall-Mounted Carbon Monoxide Detector in Classroom**

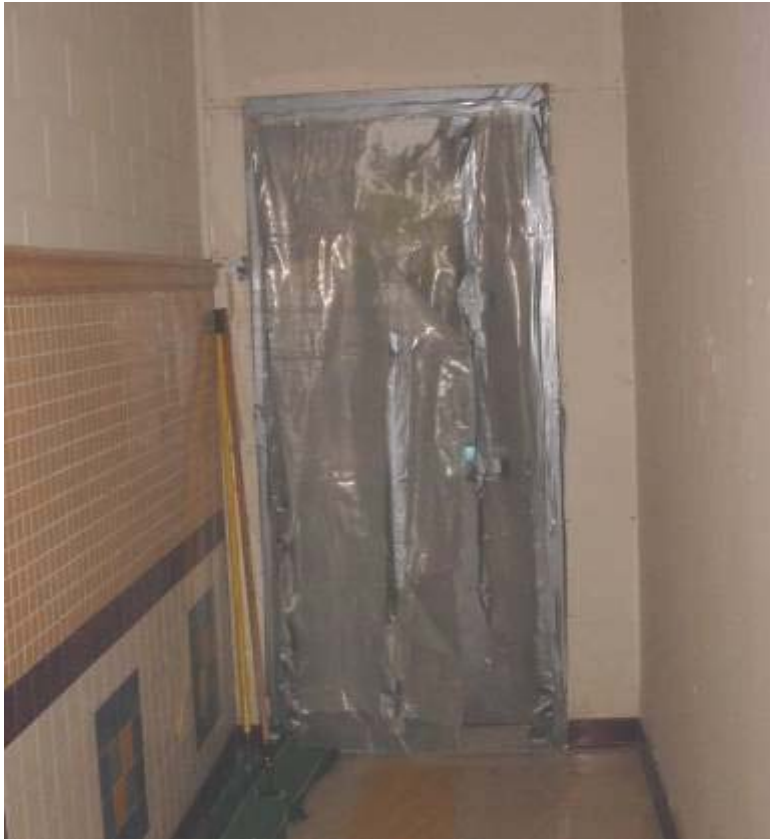
**Picture 5**

BEH staff inspected construction barriers to identify and reduce/prevent pollutant pathways. Despite a number of previous recommendations (JES IAQ assessments in 2006 and 2007), BEH staff found several breaches regarding construction barriers. The plastic construction barrier on the first floor was loose/damaged (Pictures 5 and 6); whereas the second floor had *no* such barrier installed over the door that enters into the construction zone (Pictures 7 and 8). BEH staff examined classroom C-243 directly adjacent to this area and found the door to the construction zone sealed tightly with duct tape and caulking (Picture 9). Classroom C-143 was also sealed with duct tape, however the tape was failing along the top corner of the door (Picture 10). These findings were reported to school officials at the time of the assessment with

**First Floor Construction Barrier**

the recommendation to re-seal all construction barriers. Most importantly, these barriers should be inspected on a daily basis to ensure integrity.

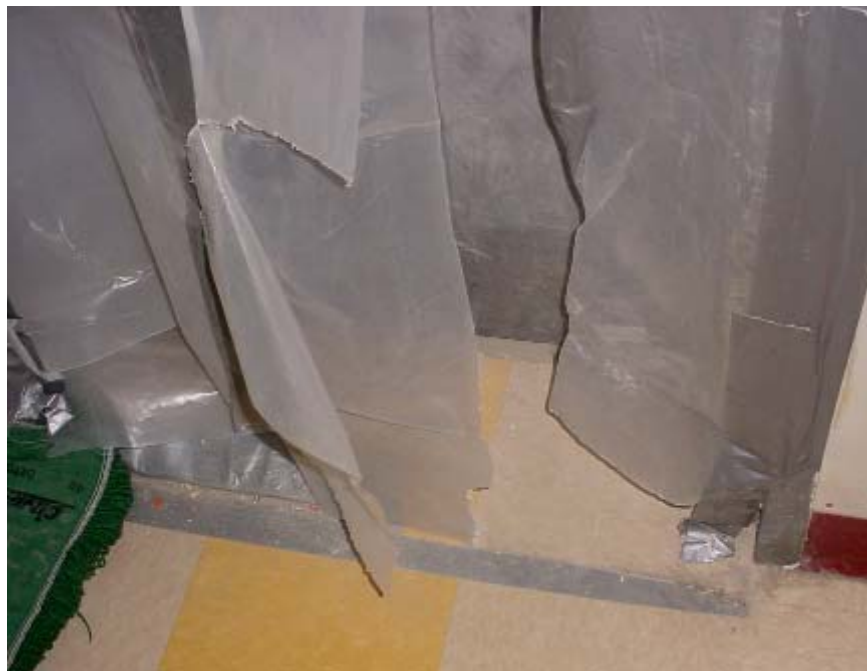
**Picture 6**

**Close-Up of Bottom of First Floor Construction Barrier in Preceding Picture,  
Note Torn Plastic and Duct Tape**

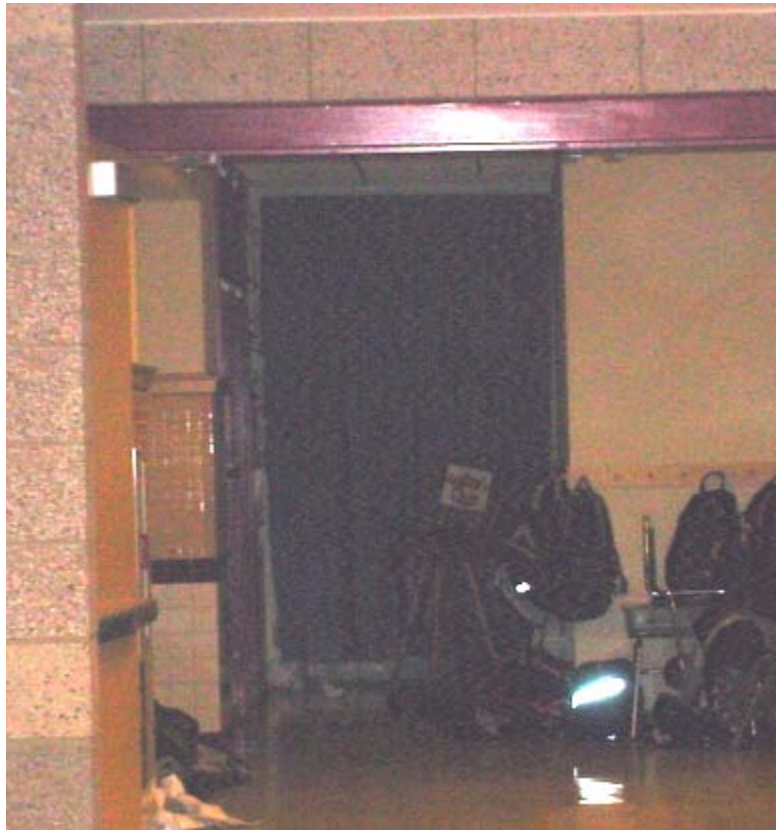
**Picture 7**

**2<sup>nd</sup> Floor Door to Construction Zone Covered by Hanging Curtain**

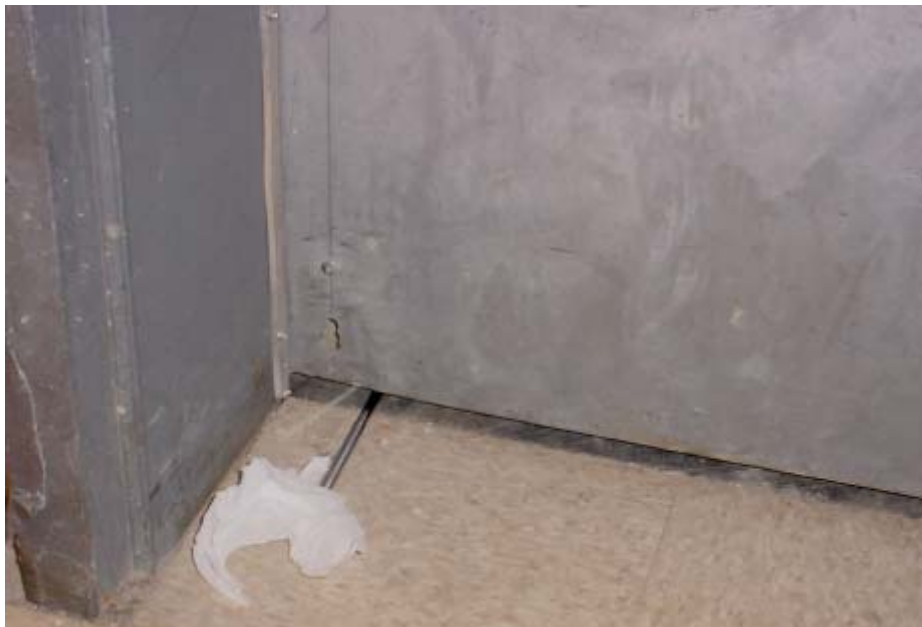
**Picture 8**

**Close-Up of Bottom of 2<sup>nd</sup> Floor Door to Construction Zone in Preceding Picture, Note Probe Inserted beneath Door Indicating That No Construction Barriers were Present Allowing Free Airflow into Occupied Areas of the School**

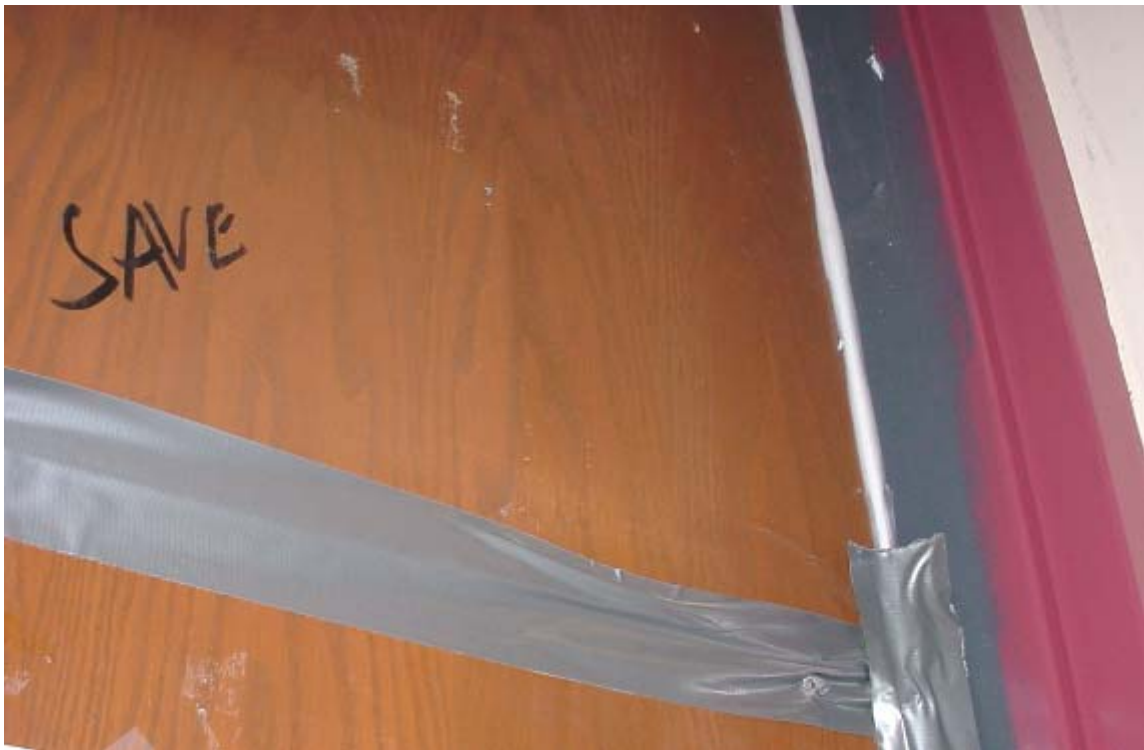
**Picture 9**

**Close-Up of Door in Classroom 243, Note Door is Sealed Tightly with Duct Tape and Caulking**

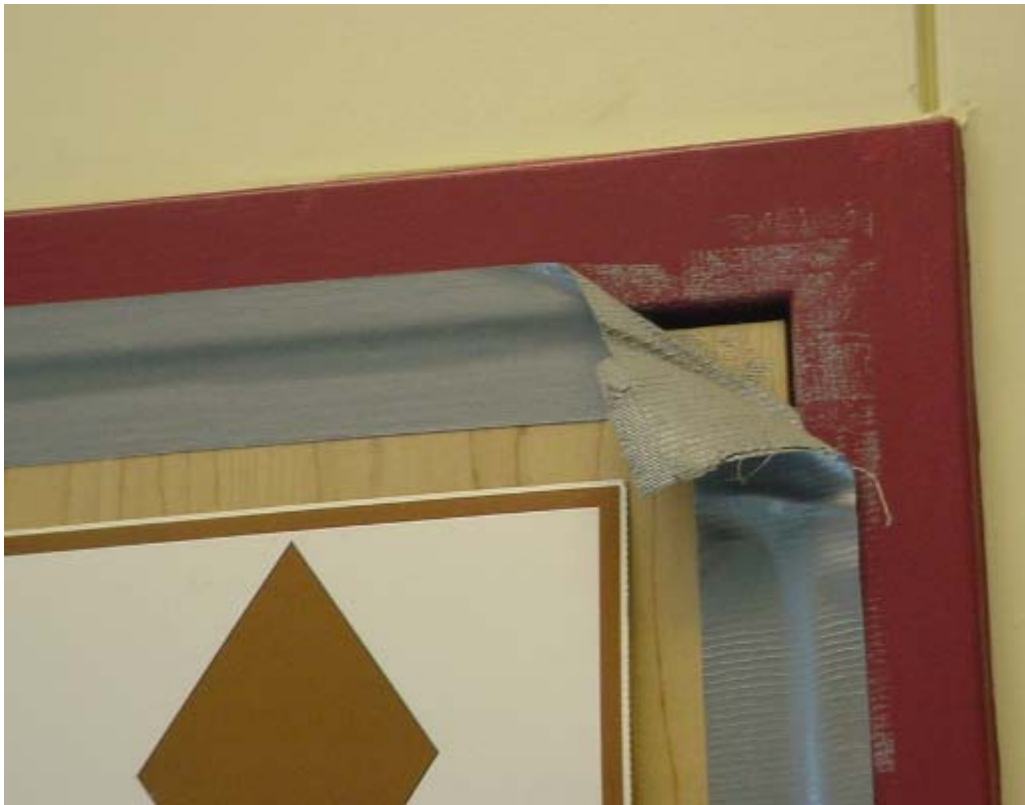
**Picture 10**

**Classroom C-143 Door Sealed with Duct Tape, Note tape Failing along Top Corner**

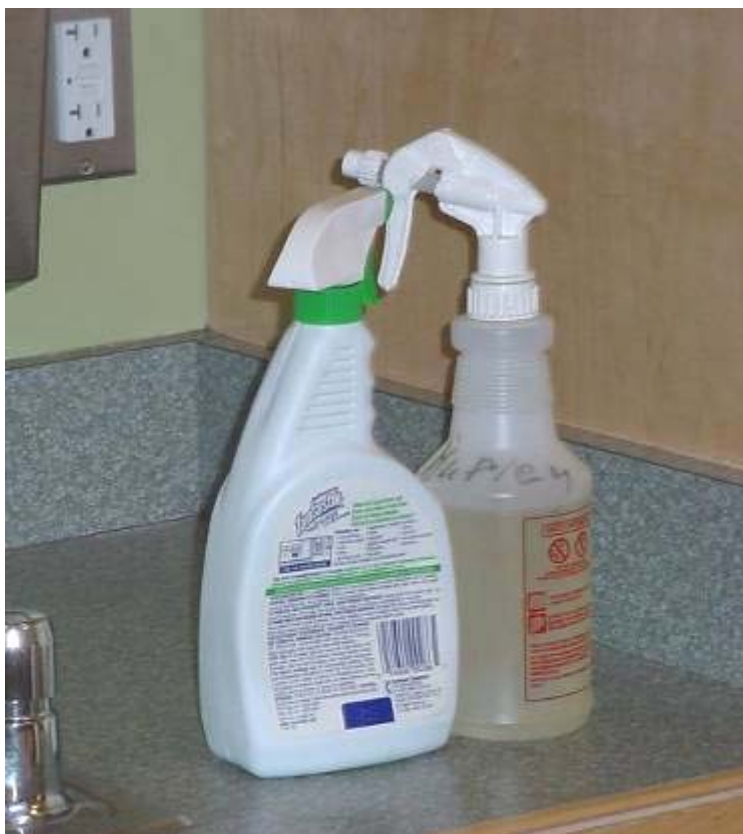
**Picture 11**

Cleaning products were found on countertops and in unlocked cabinets beneath sinks in a number of classrooms. Like dry erase materials, cleaning products contain VOCs and other chemicals (Picture 11). These chemicals can be irritating to the eyes, nose and throat and should be kept out of reach of students.

**Spray Cleaning Bottles on Countertop in Classroom**

5. Use openable windows in conjunction with mechanical ventilation to facilitate air exchange. Care should be taken to ensure windows are properly closed at night and weekends to avoid the freezing of pipes and potential flooding.
6. Clean personal fans periodically of accumulated dust.
7. Store cleaning products properly and out of reach of students. Ensure spray bottles are properly labeled. *All* cleaning products used at the facility should be approved by the school department with MSDS' available at a central location.
8. Replace latex-based tennis balls with latex-free tennis balls or glides.

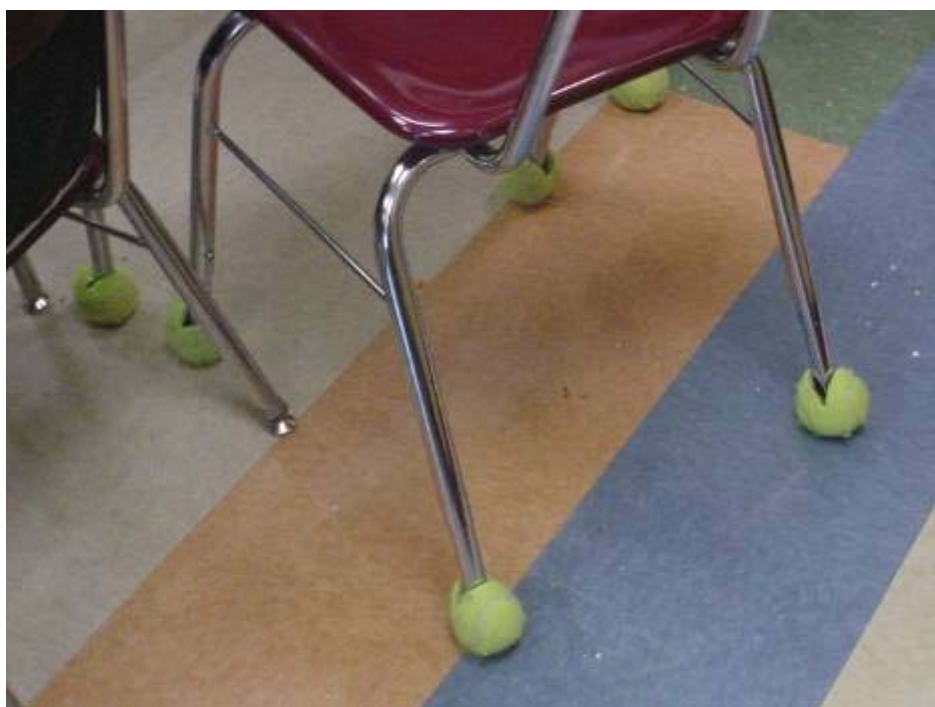
**Picture 12**

Tennis balls were observed on the chair legs despite previous recommendations (Picture 12). Tennis balls are made of a number of materials that are a source of respiratory irritants. Constant wearing of tennis balls can produce fibers and cause TVOCs to off-gas. Tennis balls are made with a natural rubber latex bladder, which becomes abraded when used as a chair leg pad. Use of tennis balls in this manner may introduce latex dust into the school environment. Some individuals are highly allergic to latex (e.g., spina bifida patients) (SBAA, 2001). It is

recommended that the use of materials containing latex be limited in buildings to reduce the likelihood of symptoms in sensitive individuals (NIOSH, 1997).

**Tennis Balls on Chair Legs in Classroom**

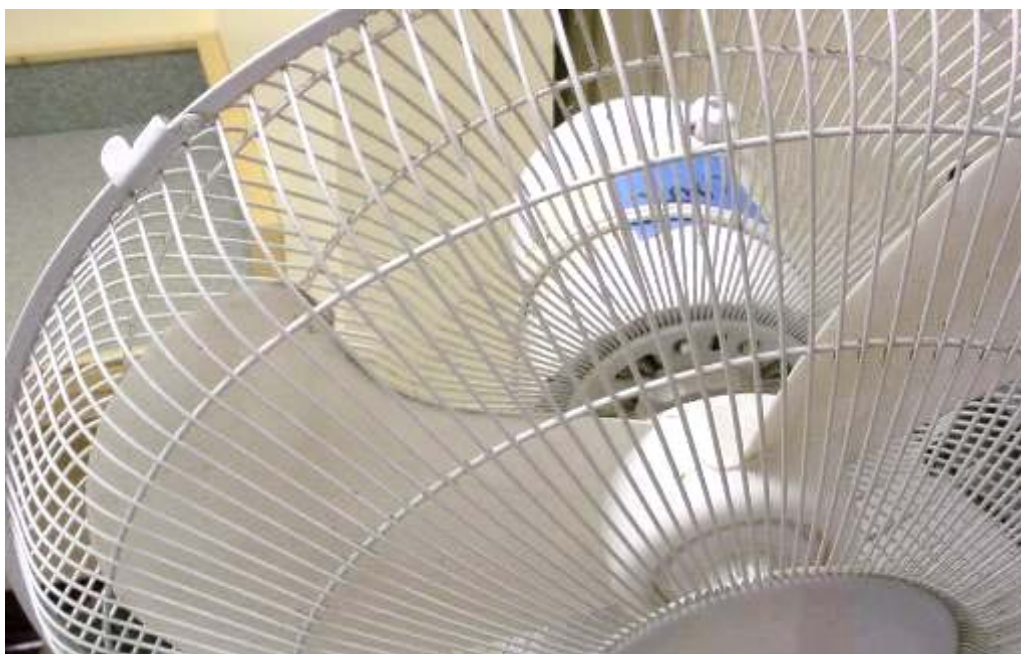
**Picture 13**

Finally, a few classrooms had personal fans (Picture 13) that were observed to have accumulated dust. Re-activated fans can also aerosolize dust accumulated on vents/fan blades.

**Accumulated Dust/Debris on Fan Blades/Cage**
